Caught In/Between Steel Beam and Boom Lift

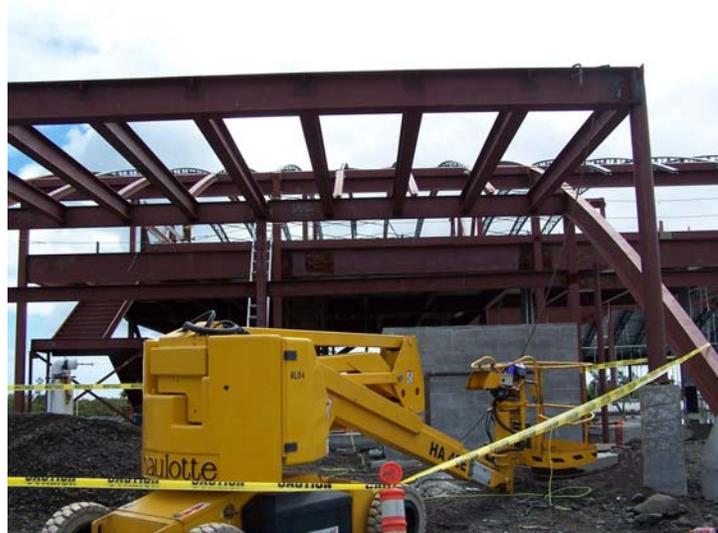
In mid-2006, a welder was killed when his head was caught between a steel beam and the control panel of the boom lift he was working from. The victim had been working alone welding a steel beam from an articulated boom-supported aerial work platform. A co-worker noticed that the victim was no longer moving and shouted out his name. He remained unresponsive. Other co-workers tried to lower the boom, but the key to switch the basket controls from the basket to the ground was missing. They tried to use a forklift to push the basket down, but that only bent the basket side rail. Finally an employee used a crescent wrench to open the hydraulic lines, which released the pressure and lowered the basket. The victim was not breathing so co-workers began to administer CPR, finally driving him to the nearest hospital approximately 2 miles away. He was pronounced dead 30 minutes later. Cause of death was traumatic compression asphyxia.

1. Train employees in the safe use and operation, including emergency procedures of the specific equipment to be used, e.g. the switchover key and the emergency lowering system. Never assume that all such equipment operate in the same way or have the same features.
2. Follow manufacturer’s instructions regarding inspection, maintenance, and operations, including the assignment of the switchover key to a person trained and responsible for emergency and rescue.
3. Manufacturers are encouraged to provide pressure sensor/relief valves in accordance with the International Organization for Standardization (ISO) Standard for articulated boom-supported aerial work platforms.

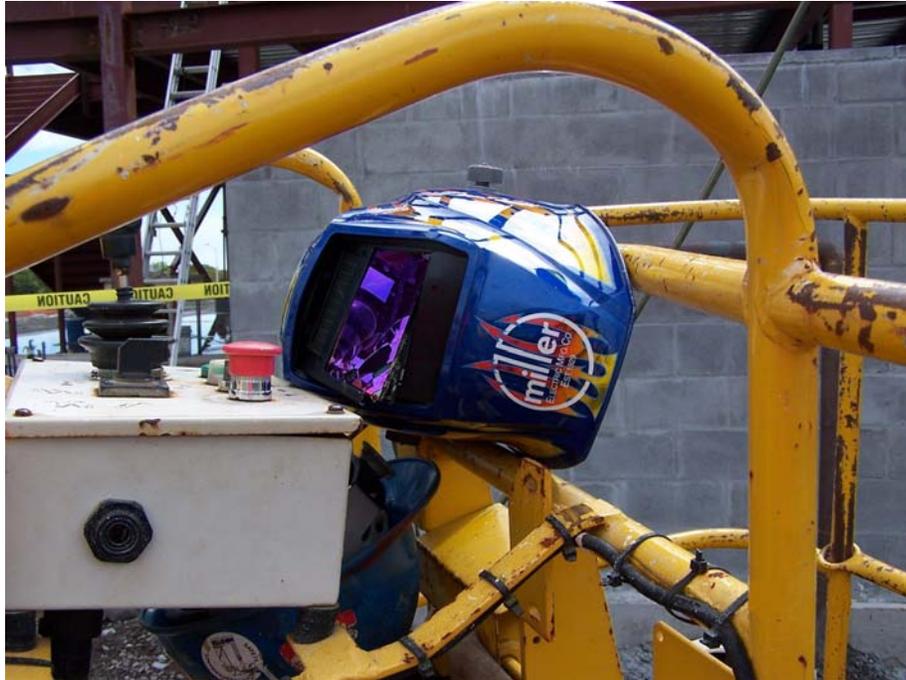
It was found that the boom lift was rented, and that no detailed inspection was performed upon accepting the equipment. The equipment rental company gave a demonstration of how to operate the lift. A selector switch on the base is used to give control of the lift to either the control panel in the lift basket or the one on the base. Switching control from one panel to the other requires the use of a key, which can be removed after the selection is made. The operating manual states that the key is to be “removed and kept by a person on the site who is properly trained in emergency and rescue operations.” The employer had not read the manual and did not assign the key to an appropriate person. The manual also describes how to operate the emergency lowering system, using a hand-operated hydraulic pump on the base of the machine, in the event of a power failure or other such emergency. Employees were not trained on the use of the emergency lowering system.

The equipment was inspected and no defects were found. It is believed that the victim inadvertently depressed the lift controls and became so wedged between the steel beam and the control panel that he could not reach the controls.
