Crushed by Front End Loader

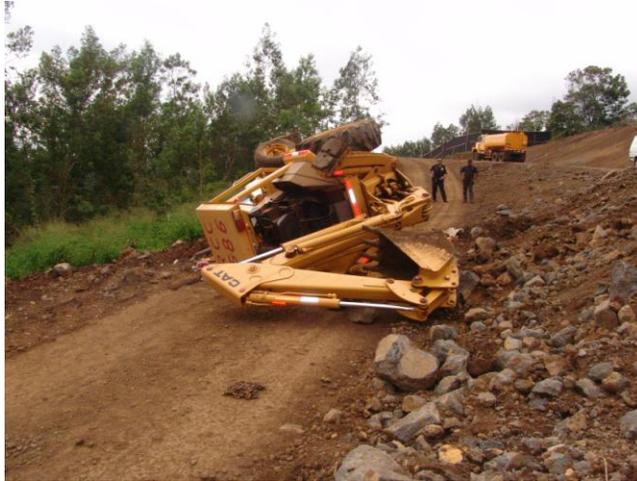
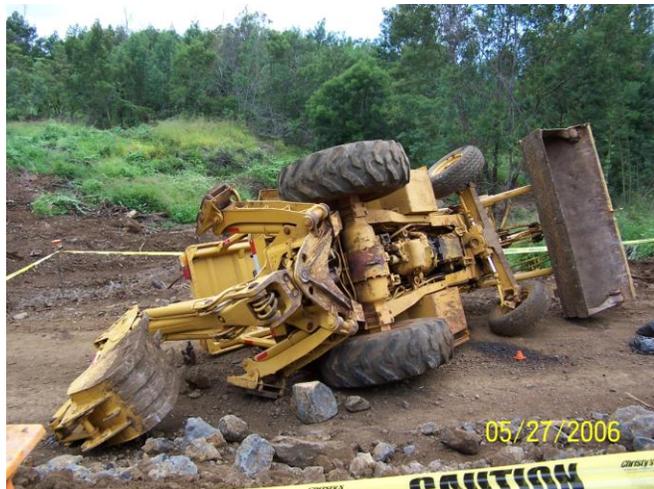
In mid-2006, a laborer was killed when the front-end loader he was operating tipped over on an incline along the side of a dirt road. The victim was assigned to clean-

The investigation found that the victim had apparently parked the backhoe along the side of the upper dirt road when it began to slide sideways along the inclined median strip between the upper and lower roads. The bucket apparently “grabbed” the terrain, causing the backhoe to flip on its side. The victim, who was not wearing a seat belt was crushed by the cab roll-over protective structure.

Recommendations:

Enforce work rules through a program that:

1. Notifies all employees of the work rule, making sure that there is no ambiguity in its application and including the reason why the work rule is necessary for the safety of the jobsite.
2. Include the monitoring of safety performance and behavior into a regular jobsite inspection program.
3. Uniformly enforce the work rule – without exception. If exceptions are necessary, perform the necessary training.
4. Involve all employees in the safety program so they understand what their responsibilities are with regard to their own safety and the safety of their co-workers.
