## #9: Pinned under Metal Concrete Form

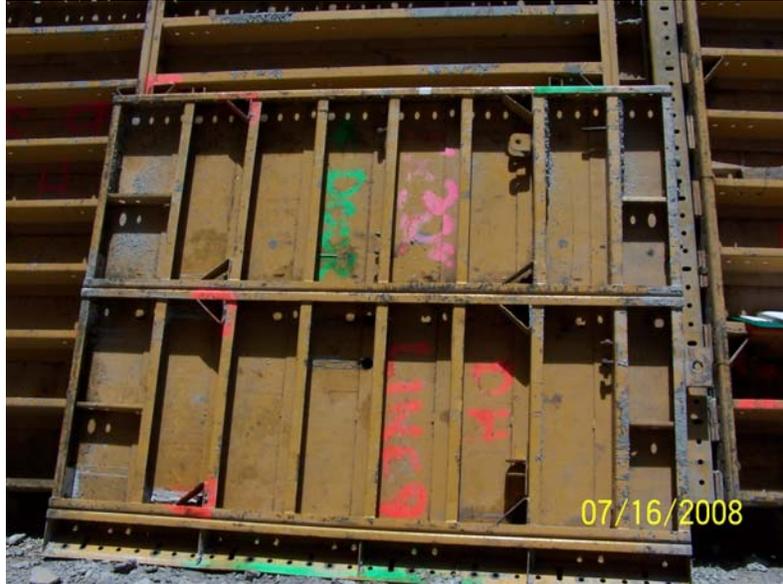
In mid-2008 a thirty year old carpenter was struck and pinned by a metal concrete form while he was working to get it ready for stripping. The carpenter was attached to and on the concrete form when it separated from the concrete wall and tipped onto the worker. The victim sustained a fractured pelvis bone and injuries to his collar bone and knee.

The victim was attached to the metal concrete form by way of his personal fall arrest gear; and he was properly trained through safety orientation training, fall protection training and weekly foreman safety talks.

The investigation determined that the metal concrete form was not effectively secured from displacement. The form ties and braces were removed before the form was attached to a crane hook, and it is believed that the victim leaned away from the metal concrete form causing the form to tip over in the direction of his lean.

1. Review and revise the principle steps of the Activity Hazards Analysis (AHA) for installing and stripping metal concrete forms procedures.
2. Train and document all training of employees in the improved AHA.
3. Ensure that employees inspect and confirm that the form ties, form braces, tie back (rebar) wires, or other means of securing the metal concrete form to the wall are in place and are in good condition before beginning work on the form.
4. Train workers not to tie-off to the metal concrete form when tie-off can be safely done by connecting to the vertical rebars of the concrete wall.
