## #8: Fall from Roof

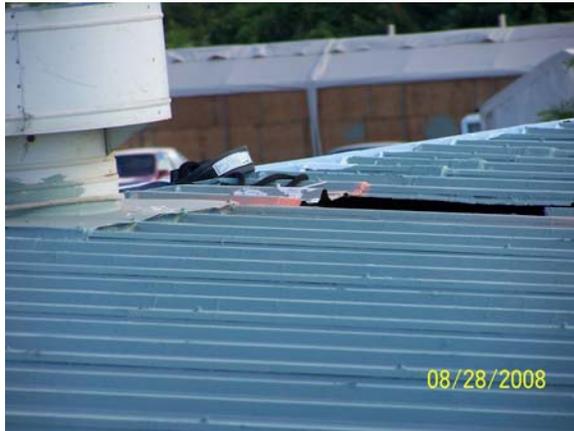
In mid-2008, a twenty-five year old roof worker was severely injured when he fell 24' through a fiberglass skylight and landed on the concrete floor below. The laborer was applying a coat of roofing material with a roller pole when he fell through the skylight. As a result of the fall, the victim broke his right elbow and his pelvis on the right and left sides.

The victim stated that he had never received fall protection training prior to the accident; the company does not have records of employees receiving fall protection training when working at heights above 6 feet. On the day of the accident, none of the workers on the roof were using a fall protection system. One of the workers had previously used a body belt in place of a full-body harness while working on the roof. The skylights were known to be a hazard, but no measures were taken to prevent tripping in or stepping into a skylight.

1. Train employees in fall protection before they are allowed to work at levels above 6 feet in height.
2. Develop Standard Operating Procedures and/or conduct a Job Hazard Analysis prior to performing work tasks.
3. Ensure that all employees use appropriate fall protection systems when working at heights above 6 feet.
4. Management should conduct routine audits periodically to ensure job safety.
5. A copy of the company Safety and Health Program should be provided and clearly communicated to all employees.
6. Provide body harnesses as part of a personal fall arrest system. Body belts were disallowed effective January 1, 1998.
