#11: Struck by Wood Beam

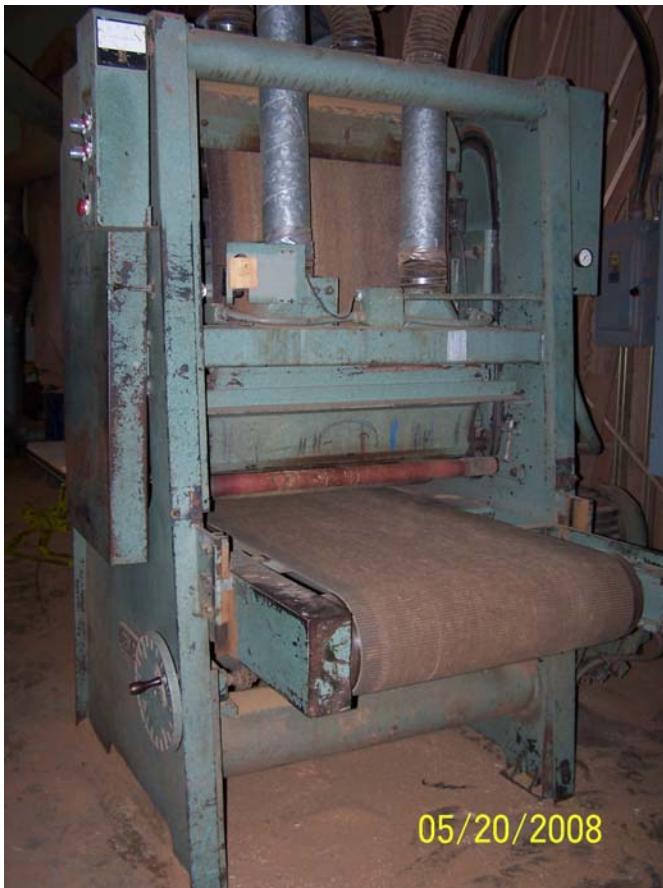
In mid-2008, a thirty-four year old lead mill wood worker was killed when a laminated teak wood wall cap beam was kicked back out of the 30-inch, wide-belt sander and struck him in the abdomen. The wide-belt sander was purchased used approximately seven years before the accident; it did not come with its operation and maintenance manuals. The company asserted that the equipment was inspected and maintained on a regular basis by someone with 35 plus years of experience in wood working and maintaining wood working equipment. While the wide-belt sander did not have any anti-kickback features, this type of equipment are not known to have kickback issues. On the day of the incident, the victim had been instructed to resize the wood beam by taking off 1/16th inch from the bottom of the wood beam. The victim was taken to the hospital where he passed away from internal injuries.

The investigation did not find any visible defects with the equipment in question, and concluded that the condition and maintenance of the wide-belt sander is a non-contributing cause to the accident. The investigation found that the employer did not have effective work practices that minimized employee exposure to wide-belt sander kick back hazards.

1. Adapt and develop operational policies and procedures into written operating instructions and safety procedures for wood working machinery and equipment used.
2. Train and/or retrain their wood shop workers in the employer's written wood working machinery and equipment operating instructions and safety procedures.
3. Train wood shop workers in policies and procedures that minimize the need and/or amount of time workers need to spend at the in-feed side of the wide-belt sander.
