#7: Precast Wall Piece Dropped from Crane

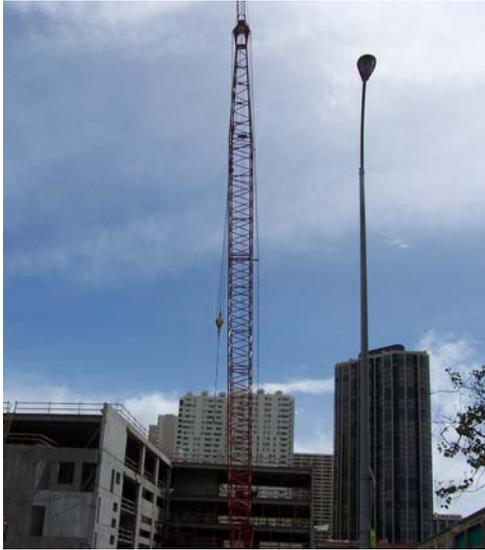
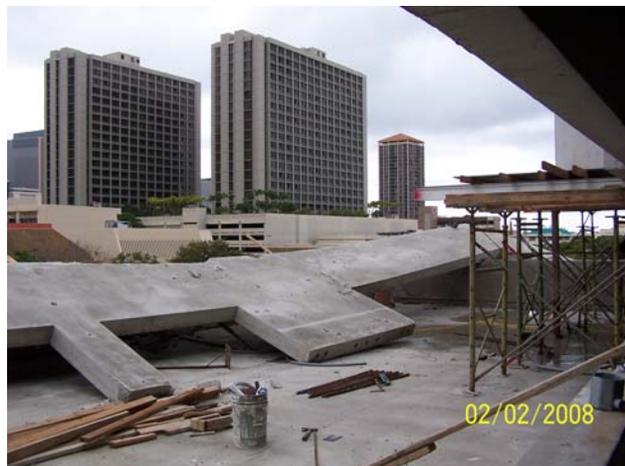
In early-2008 a 56,300 pound precast wall piece was dropped on the site building from a crane. The crane operator dropped the load when he felt the crane begin to tip as he was setting the precast wall into place. There were no injuries or fatalities due to the accident, and the incident was confined to the worksite. However, the total cost of the damage to the crane and building is estimated at \$270,000. The crane involved in the accident was approximately 38 or 39 years old; however the crane underwent regular inspection and maintenance and was deemed certified and fit for service.

The investigation determined that the proper procedures were not followed to determine the weight of the load and the crane's capacity. The crane was operating outside the 75% safety factor and the crane operator was working with an expired Hoisting Machine Operator's Certificate.

1. Ensure that all workers adhere to the manufacturer's specifications prior to and while the crane is in operation.
2. Provide guidelines that the crane operator and lift crew should not exceed 75% capacity of the crane.
3. Implement periodic checks or audits to ensure the crane operator is following the manufacturer specifications.
4. Train workers to verify both the crane's capacity for each lift as well as the weight of the load prior to the lift.
5. Ensure all workers have their certifications current and updated before they begin work.
